Inspection Report

Top To Bottom inspections

Date: 2020-07-16	Time: 09:00 AM	Report ID: 20-42
Property: 5015 Siminoff Grand Forks BC V0H 1H4	Customer: Mr. Brandon Buick	Real Estate Professional: Logan Melville Grand Forks Realty

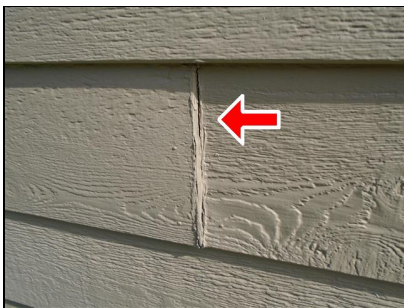
1.0 Item 1(Picture) South side

1.0 (1) The caulking has deteriorated and cracked in multiple locations. These areas are vulnerable to water penetration. Repair caulking as soon as possible and check annually after is recommended.

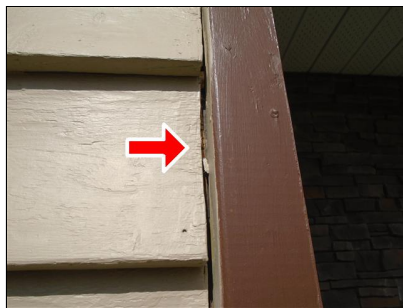
1.0 Item 2(Picture) All corners should be caulked

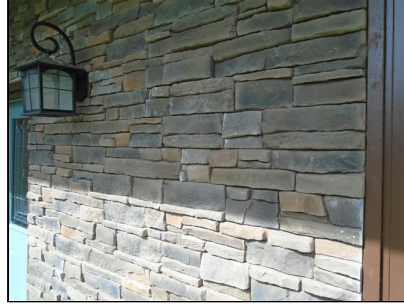
1.0 Item 3(Picture) East side

1.0 (2) Some of the stone facade is loose. It remained intact at the time of inspection, but pieces could fall off in the future. Monitor closely for repairs.

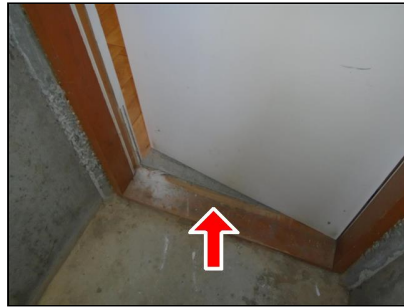
1.1 The door pictured is difficult to operate. This may worsen or improve with the changing seasons. Repair as desired.

1.1 Item 1(Picture) Basement entrance (rubs at the bottom)

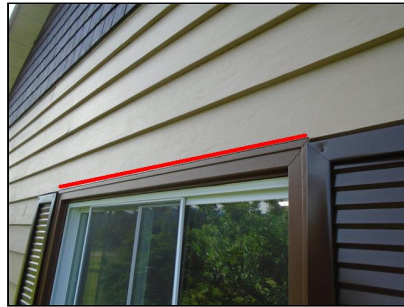
1.2 Item 1(Picture) North side

1.2 The window pictured is missing a drip cap flashing. Flashing helps divert water away from vulnerable areas such as windows and doors. There is possible hidden damage. Installation of drip cap flashing as soon as possible is recommended.

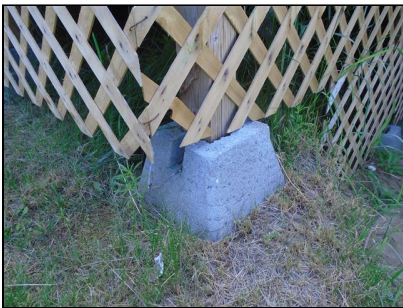
1.3 (1) The deck pictured is questionably built. While it feels strong under foot the general construction is mediocre. Further investigation by a qualified tradesman prior to use is recommended.

1.3 Item 1(Picture) Improper footing (not frost protected)

(1) The deck pictured is questionably built. While it feels strong under foot the general construction is mediocre. Further investigation by a qualified tradesman prior to use is recommended.

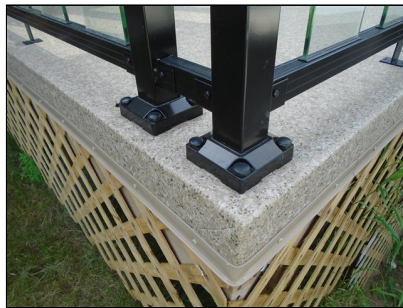
1.3 Item 2(Picture) Top mount railings are vulnerable to water penetration

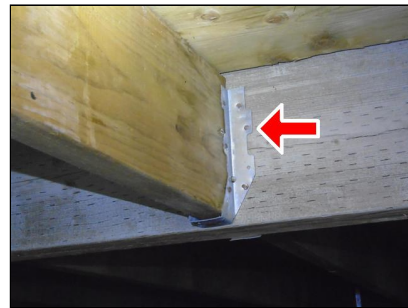
1.3 Item 3(Picture) Improper fasteners in joist hanger

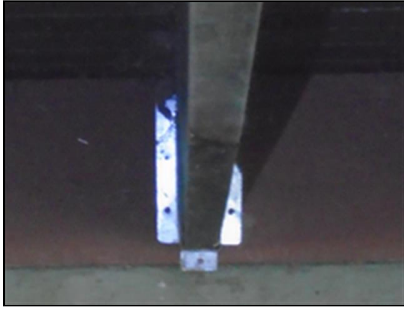
1.3 Item 4(Picture) Missing fasteners in joist hanger

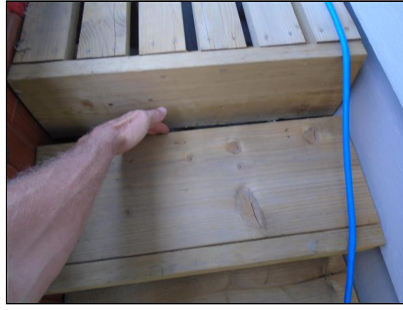
1.3 Item 5(Picture) Stair treads loose

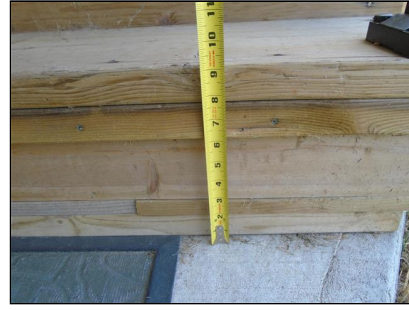
1.3 Item 6(Picture) Uneven step (refer to item 7)

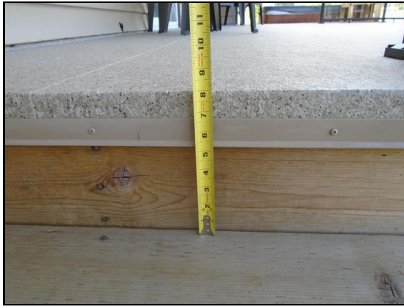
1.3 Item 7(Picture) Uneven steps are a trip hazard

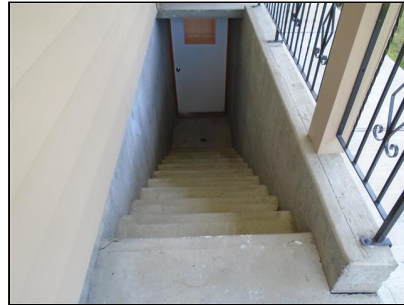
1.3 Item 8(Picture) Basement entrance

1.3 (2) The stairs pictured do not have a handrail. A fall or other injury can occur. Installation of such rails as soon as possible by a qualified tradesman is recommend.

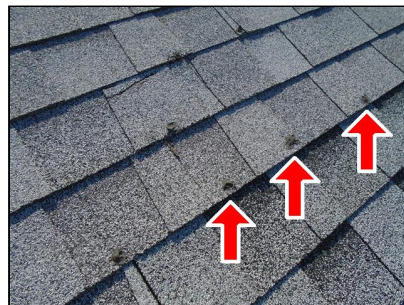
2.0 Item 1(Picture) North end

2.0 There are multiple exposed nails on the roof. Exposed nails are vulnerable to water penetration. They should be sealed as soon as possible buy a qualified tradesman.

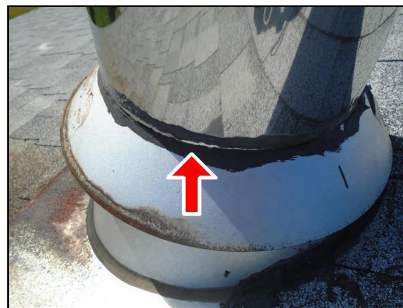
2.2 Item 1(Picture) Metal chimney

2.2 The metal chimney depends on caulking to maintain its seal. Water can penetrate the roof at this point if not properly managed and may have hidden damage. Apply caulking as soon as possible, and check annually after is recommended.

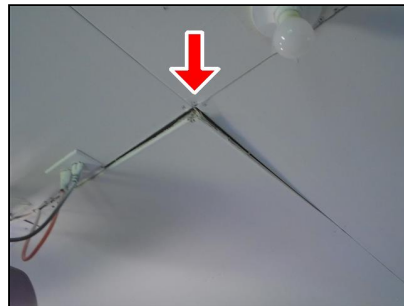
3.0 The ceiling in the garage is damaged. This appears to be minor and cosmetic. Repair as desired.

3.0 Item 1(Picture) Loose drywall

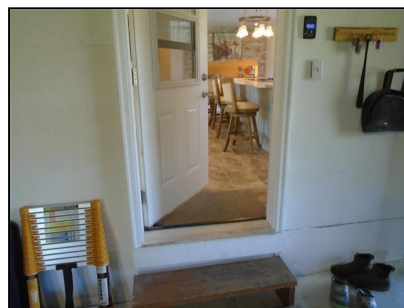
3.4 Item 1(Picture) Garage/house door

3.4 The entry door from the garage into the house does not close on its own. This is a safety hazard as vehicle exhaust can enter the house and also compromises the firewall separation. Recalibration of the automatic closing hinge upon moving in is recommended.

The entry door from the garage into the house does not close on its own. This is a safety hazard as vehicle exhaust can enter the house and also compromises the firewall separation. Recalibration of the automatic closing hinge upon moving in is recommended.

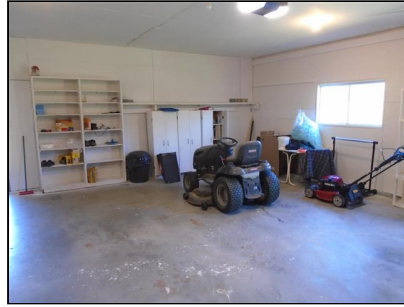
3.8 Item 1(Picture) Storage

3.8 Inspection of garage limited by contents. There could be deficiencies unseen at the time of inspection

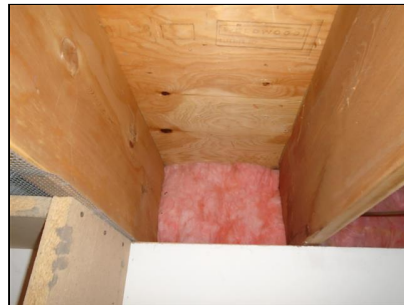
4.2 There are several locations where the vapor retarder has become unsealed. This will allow air to escape causing increased heating costs and could create condensation issues with hidden damage. Further investigation and repair upon moving in is recommended.

4.2 Item 1(Picture) Spaces between floor joists should be sealed

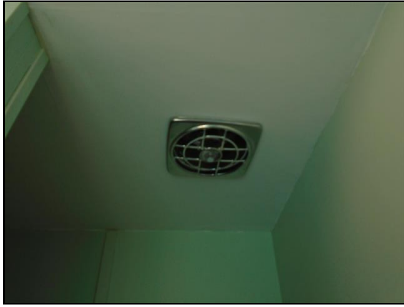
4.4 Item 1(Picture) En-suite

4.4 (1) The vent pictured is exhausting into the attic. This will add excess moisture and aid in bacterial growth. Installation of a proper exterior termination point for this vent, and further investigation of the attic prior to any use is recommended.

(1) The vent pictured is exhausting into the attic. This will add excess moisture and aid in bacterial growth. Installation of a proper exterior termination point for this vent, and further investigation of the attic prior to any use is recommended.

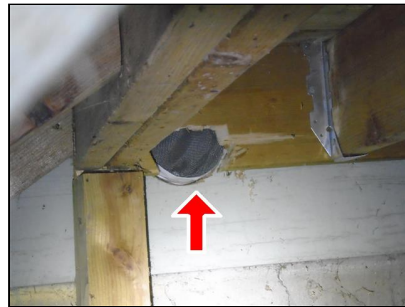
4.4 (2) The vent pictured terminates in a poor location. This allows moisture to collect on the surrounding area, which can lead to significant damage. Directing the termination point away from the house prior to use is recommended.

4.4 Item 4(Picture) Kitchen vent termination is under the deck

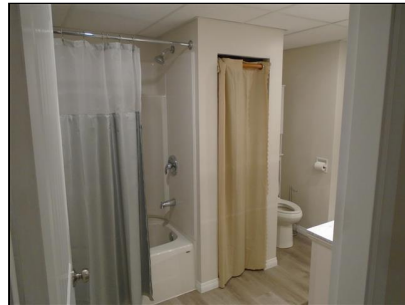
4.4 Item 5(Picture) Basement

4.4 (3) There is no active venting in the bathroom pictured. Excess moisture can build up if not vented properly. Installation of vent system upon moving in is recommended

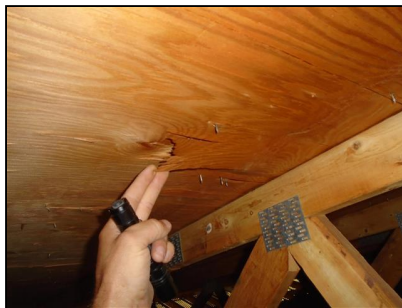
5.5 Item 1(Picture) Roughly mid-span on the east slope

5.5 The plywood pictured has delimitated causing it to loose a significant amount of its strength. The roof is weak in this area and should be reinforced as soon as possible.

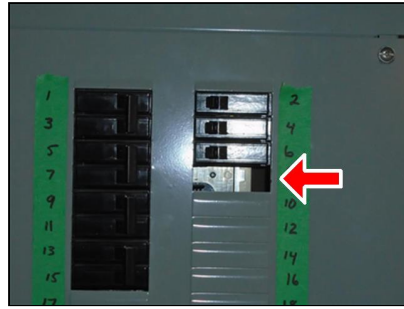
6.1 Item 1(Picture) Main panel

6.1 (1) The main panel is missing a knockout. This is considered poor practice and should be corrected as soon as possible by a qualified electrician.

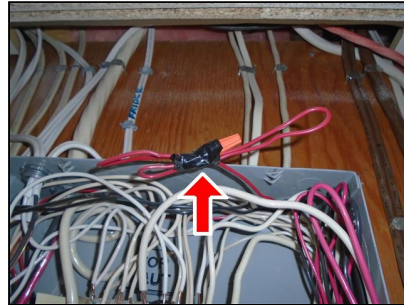
6.1 Item 2(Picture) Sub panel

6.1 (2) There is an abandoned wire in the panel. While it is not connected it does not post an immediate threat. Further investigation by a qualified electrician as soon as possible is recommended.

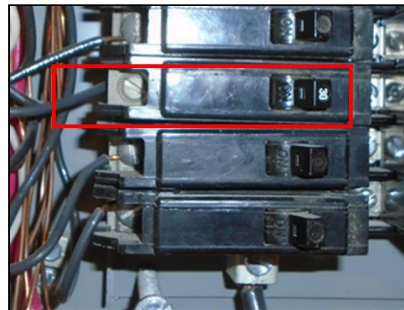
6.2 (1) The breaker shown is rated too high for the corresponding wire. This can overheat the wire before the breaker will trip and potentially start a fire. Immediate repair by a qualified electrician is recommended.

6.2 Item 1(Picture) 30 amp breaker, 3rd from the bottom, on the left side of the sub panel. This breaker should be replaced with a 15 amp to ensure the 14AWG wire it is connected to is not overloaded

(1) The breaker shown is rated too high for the corresponding wire. This can overheat the wire before the breaker will trip and potentially start a fire. Immediate repair by a qualified electrician is recommended.

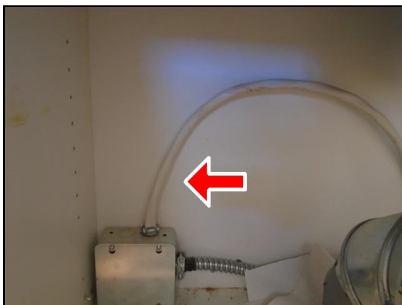
6.2 Item 2(Picture) Under kitchen stove

6.2 (2) The area pictured has an exposed wire (unprotected). This is vulnerable to physical damage. It should be covered with a conduit or boxed in for protection immediately.

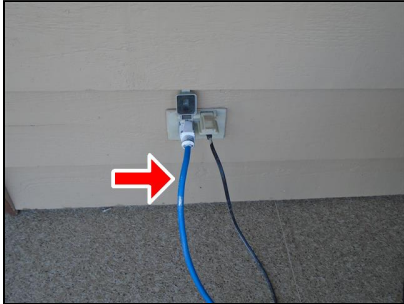
6.3 (1) There is an extension cord being used as permanent wiring. This is considered poor practice and should be disconnected and wired properly prior to use.

6.3 Item 1(Picture) Used for pool pump

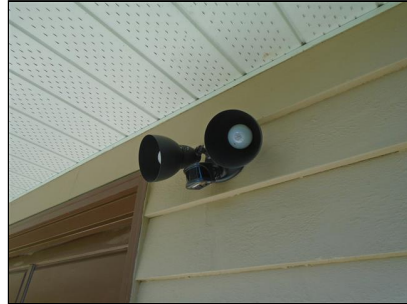
6.3 Item 3(Picture) Lights connected to garage cord (item 2)

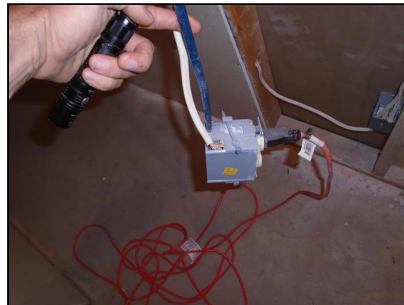
6.3 (2) The pictured fixture is loose and hanging. This is considered unsafe and should be corrected by a qualified electrician immediately

6.3 Item 4(Picture) Under stairs. This receptacle is also using an extension cord going to a freezer

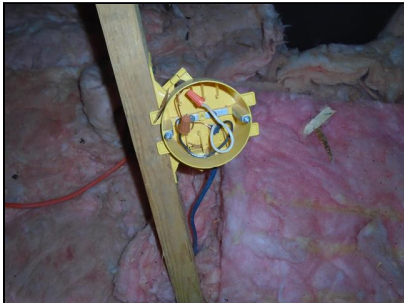
6.3 Item 5(Picture) Attic

6.3 (3) The junction box pictured is missing its cover . This is considered unsafe and should be corrected by a qualified electrician immediately.

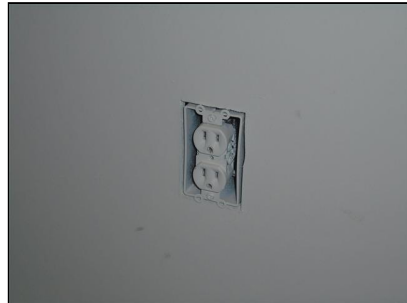
6.3 Item 7(Picture) Multiple boxes in basement

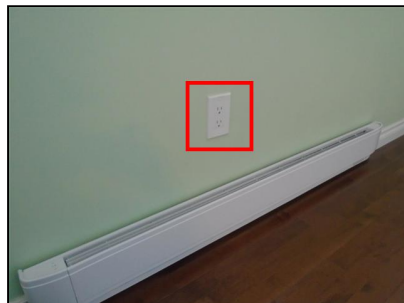
6.3 (4) The receptacle pictured is over top of an electric heater. Wires from plugged in devices can come in contact with the heater creating a dangerous situation. Discontinue use of the receptacle or use of an alternate heat source immediately is recommended.

6.3 Item 8(Picture) Multiple receptacles throughout top floor

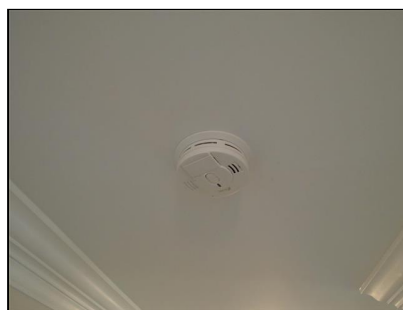
6.8 A smoke detector should be located in each bedroom and tested upon moving in to home.

6.8 Item 1(Picture) Only one found in the upstairs hallway

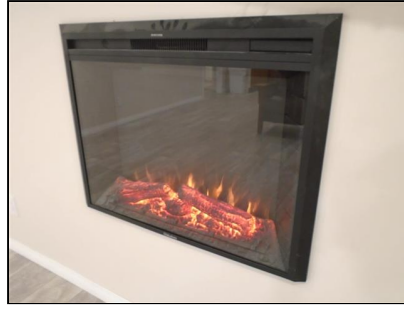
7.4 Item 1(Picture) Basement living room

7.4 The wall mount electric heater is the only heat source for the basement.

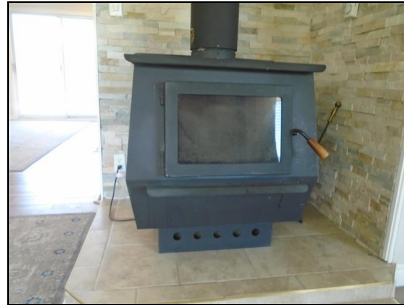
7.6 Item 1(Picture) Upstairs living room

7.6 The woodstove pictured was observed but not tested. A full W.E.T.T inspection is recommended before any operation of the woodstove.

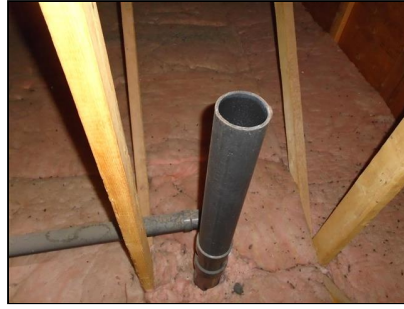
8.0 Item 1(Picture) Plumbing vent

8.0 (1) The vent pictured is dead ended in the attic. This will allow excess moisture and sewer gases into the attic. Installation of a proper exterior termination point for this vent, and further investigation of the attic prior to any use is recommended.

(1) The vent pictured is dead ended in the attic. This will allow excess moisture and sewer gases into the attic. Installation of a proper exterior termination point for this vent, and further investigation of the attic prior to any use is recommended.

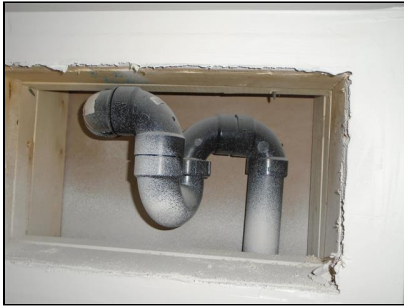
8.0 Item 2(Picture) Basement laundry

8.0 (2) There are multiple S-traps in the house. An S-trap is vulnerable to drain slow and also syphon out allowing unpleasant sewer gas to enter the house. Correction of this issue by a qualified plumber prior to use is recommended.

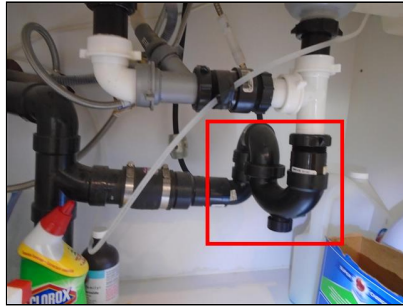
8.0 Item 3(Picture) Both upstairs and downstairs kitchens

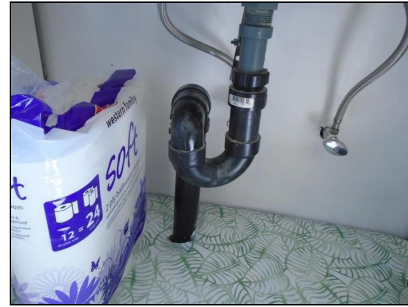
8.0 Item 4(Picture) All 3 bathrooms

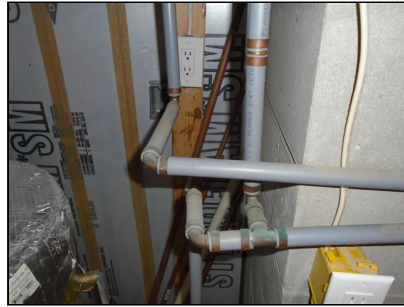
8.1 Item 1(Picture) Basement

8.1 (1) There have been failures of earlier polybutylene piping plastic fittings. Now there have been documented cases of the piping material itself failing. Possible insurance issue as some companies may require replacement of Poly-B water supply lines. Replacement can be costly. For more information visit www.poly-b.com

(1) There have been failures of earlier polybutylene piping plastic fittings. Now there have been documented cases of the piping material itself failing. Possible insurance issue as some companies may require replacement of Poly-B water supply lines. Replacement can be costly. For more information visit www.poly-b.com

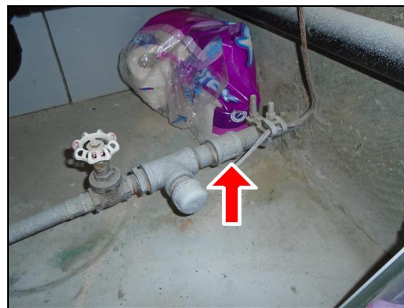
8.1 Item 2(Picture) Galvanized

8.1 (2) The inlet pipe is galvanized. This is an old system that could have failure points, and could also be an insurance issue. Further investigation and replacement by a qualified plumber prior to use is recommended.

(2) The inlet pipe is galvanized. This is an old system that could have failure points, and could also be an insurance issue. Further investigation and replacement by a qualified plumber prior to use is recommended.

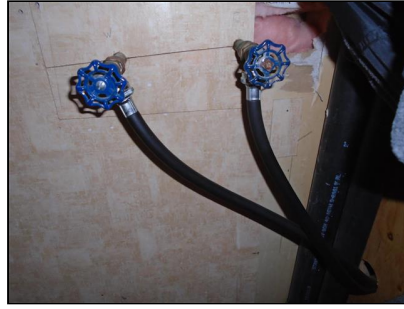
8.1 Item 3(Picture) Rubber hoses

8.1 (3) Rubber washing machine hoses have been known to fail. Replacement with steel braided hoses as soon as possible is recommended.

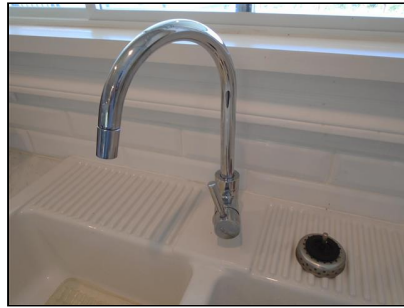
8.1 Item 4(Picture) Kitchen

8.1 (4) The faucet pictured is loose. While a leak was not detected at the time of inspection, one could start if left unsupported. Repair by a qualified tradesman before use is recommended.

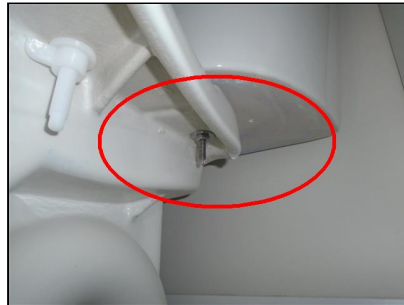
8.2 Item 1(Picture) Basement

8.2 (1) The pictured toilet leaks. Leaks of this nature can quickly damage areas around them. Repair by a qualified plumber as soon as possible is recommended.

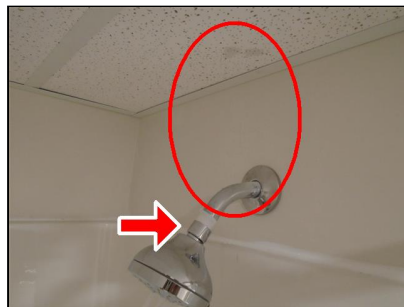
8.2 (2) The pictured faucet leaks. Leaks of this nature can quickly damage areas around them. Replacement by a qualified plumber as soon as possible is recommended.

8.2 Item 2(Picture) Basement shower is spraying on the wall and ceiling behind.

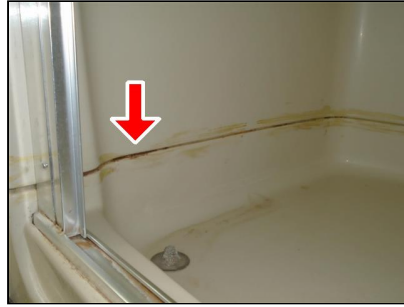
8.2 Item 3(Picture) Main bath upstairs

8.2 (3) The seal at the bottom of the pictured shower has deteriorated and may be leaking. This can quickly damage the shower and surrounding area. Further investigation and repair prior to use is recommended.

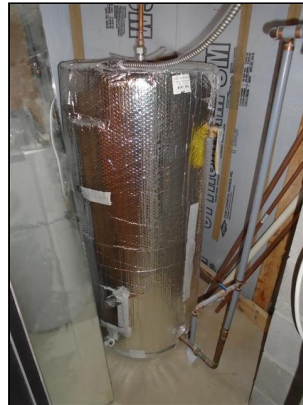
8.3 The water heater is nearing the end of its expected life. While it may last a few more years it should be replaced prior to closing.

8.3 Item 1(Picture) Manufactured in 2012

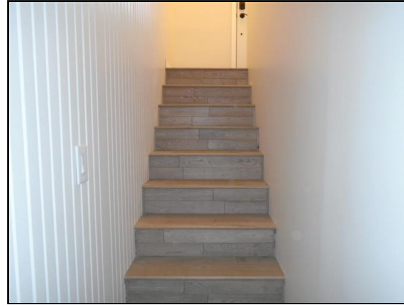
9.3 Item 1(Picture) Basement stairs

9.3 The stairs pictured do not have a handrail. A fall or other injury can occur. Installation of such rails as soon as possible by a qualified tradesman is recommend.

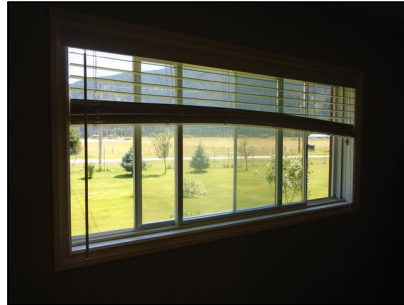
9.6 There are multiple windows that are difficult to operate. This may worsen or improve with the changing seasons. Repair as desired.

9.6 Item 1(Picture) Almost all windows

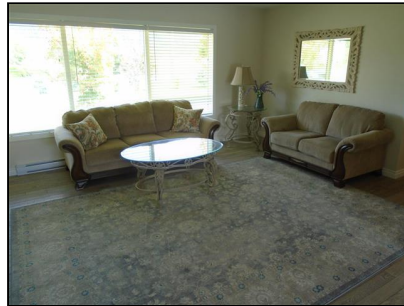
9.7 Item 1(Picture) Furniture

9.7 Reduced viewing in living areas, closets, and cupboards due to furniture and storage items. There is potential for hidden defects in these areas.
