Inspection Report

Top To Bottom inspections

Date: 2020-07-16	Time: 09:00 AM	Report ID: 20-42
Property: 5015 Siminoff Grand Forks BC V0H 1H4	Customer: Mr. Brandon Buick	Real Estate Professional: Logan Melville Grand Forks Realty

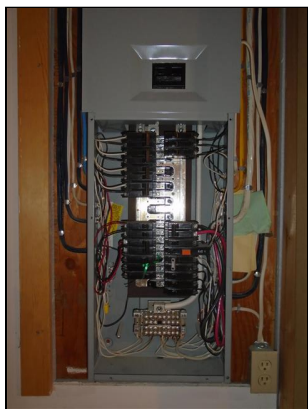
6.7 The main and sub distribution panels are located in the basement.

6.7 Item 1(Picture) Main
(Southeast corner)

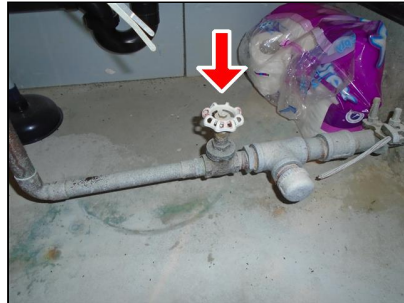
8.4 The main water shut-off is located in the basement.

8.4 Item 1(Picture) Bathroom closet

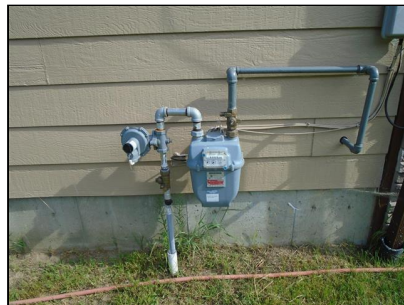
8.6 The main gas shutoff is at the meter located on the south side of the house.

8.6 Item 1(Picture) Gas meter
