Inspection Report

Top To Bottom inspections

Date: 2020-07-16	Time: 09:00 AM	Report ID: 20-42
Property: 5015 Siminoff Grand Forks BC V0H 1H4	Customer: Mr. Brandon Buick	Real Estate Professional: Logan Melville Grand Forks Realty

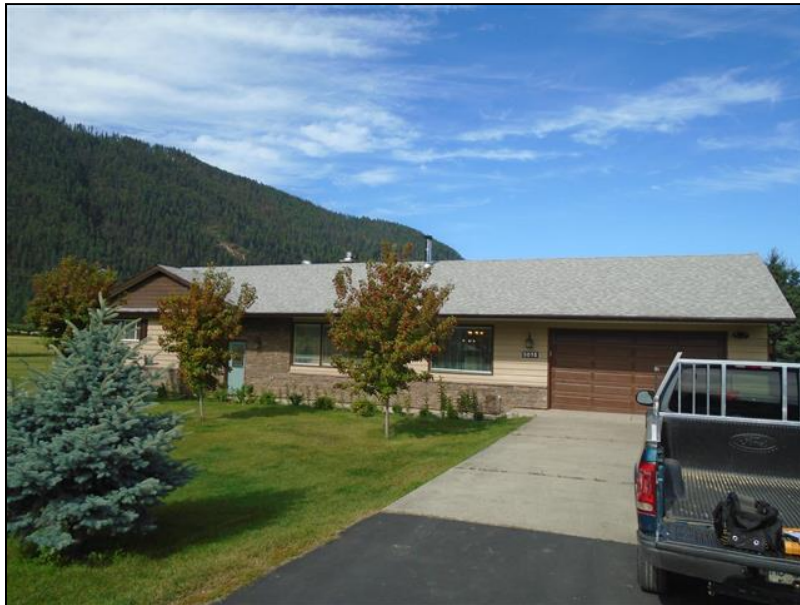
As seen from the street

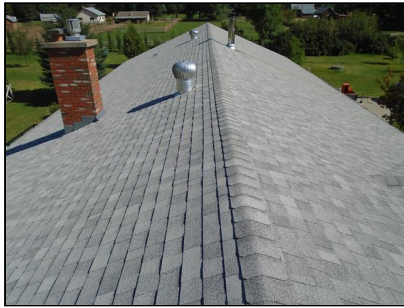
Asphalt roof

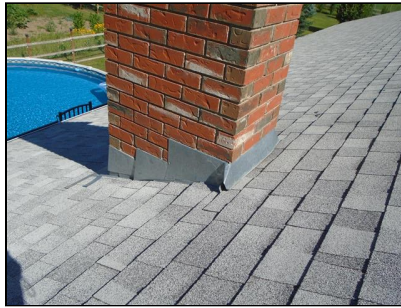
Brick chimney

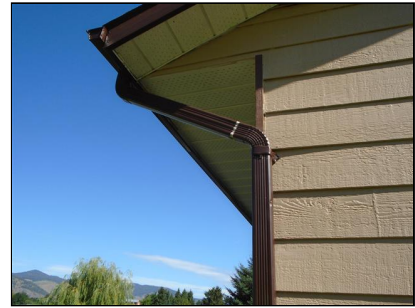
Downspout

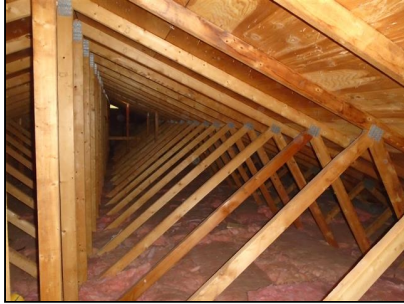
Engineered wood trusses

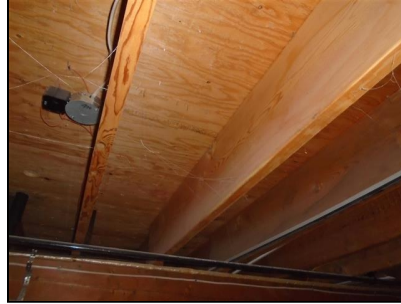
2x12 joists

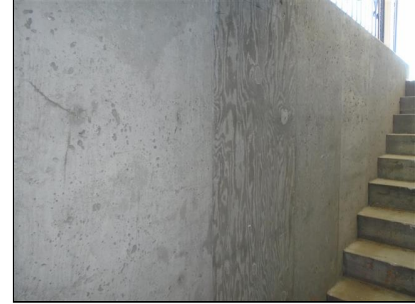
Concrete foundation

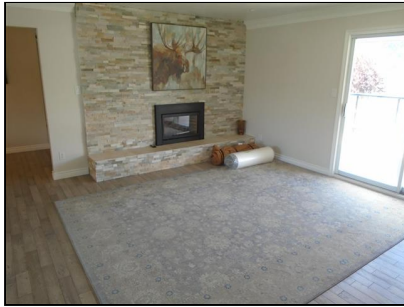
Living room

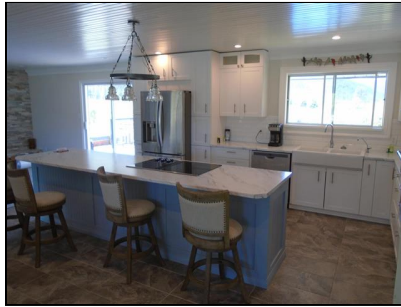
Main kitchen

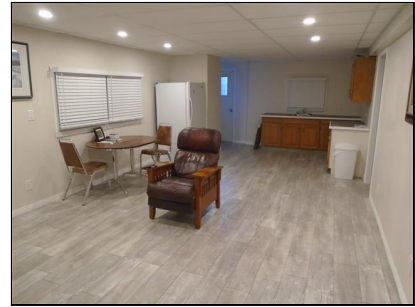
Basement
